**REPORT ON  
LIMITED REMEDIATION ACTIVITIES**

**Armstrong World Industries, Inc.**

**St. Helens, Oregon Facility**

October 30, 1989

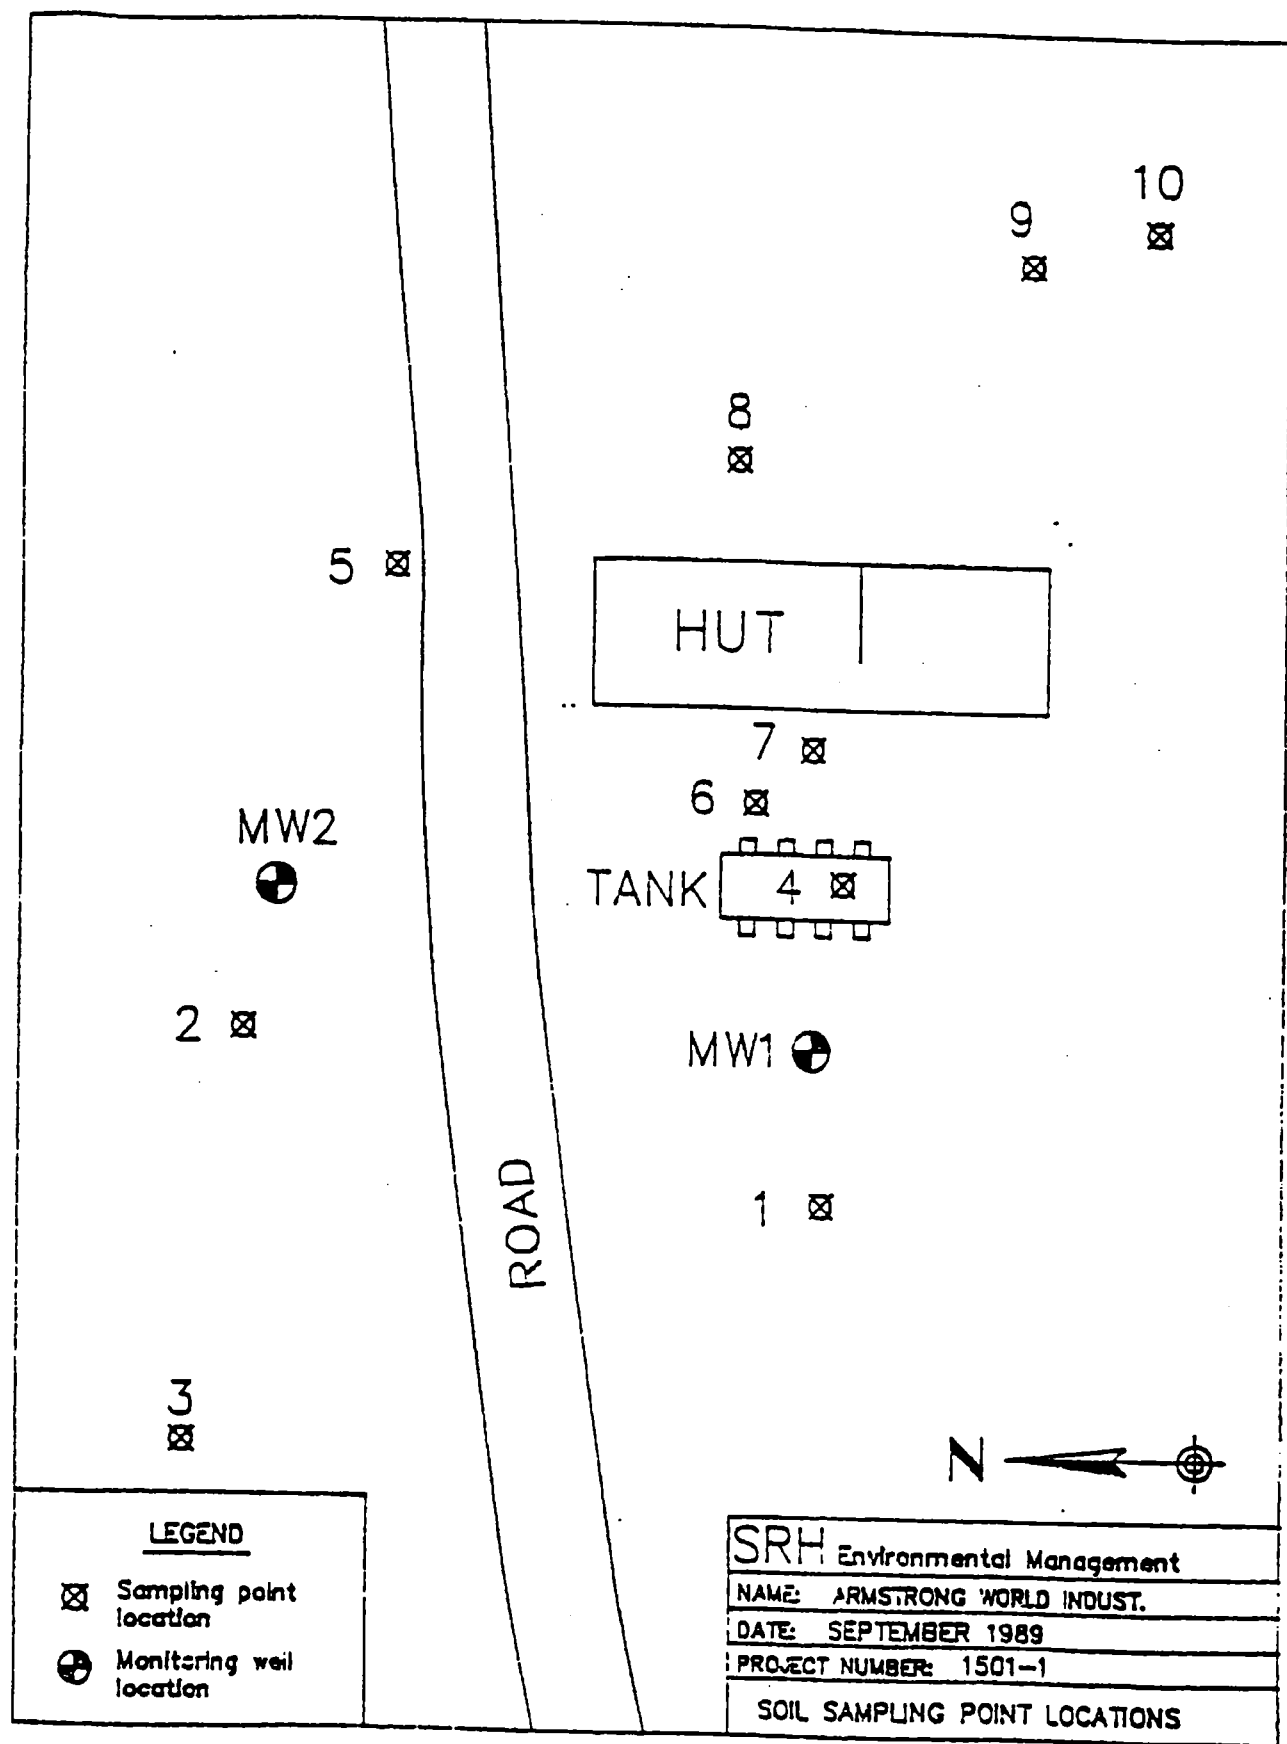
Figure 1.

A backhoe was used to excavate 10 sample locations. The first three sampling areas were randomly chosen from an area downslope from, but in the vicinity of the existing monitoring wells. The samples were taken downslope from the monitoring wells to assist in determining the surface and near-surface horizontal migration of contamination. In addition, the existing monitoring wells were sampled. The locations of the sample points and the monitoring wells are presented in figure 1.
